Ausable River Watershed Management Strategy

Essex and Clinton Counties, New York

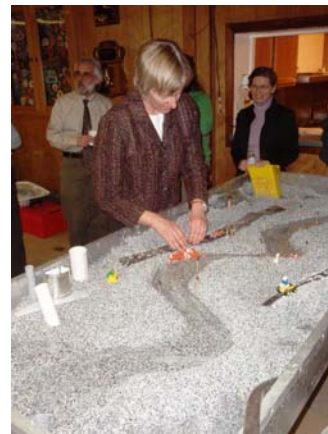
Figure 1. EMRiver stream Table demonstration. Picture taken on February 21, 2008 at the Keeseville Public Input Meeting.

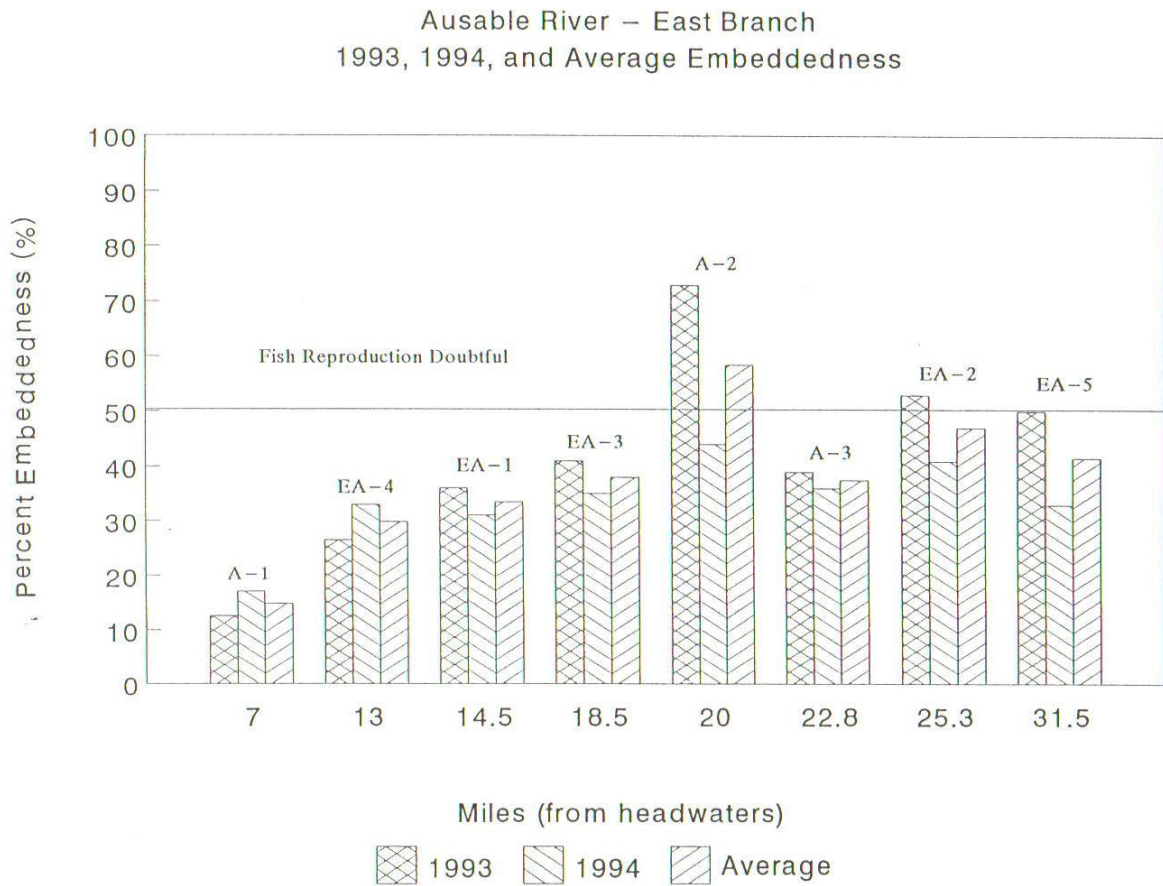
Figure B-2. Embeddedness Percentages on sites in the East Branch.

Affect of Sediment in the Ausable River: Embeddedness is a measure of the degree to which the channel bottom is covered with fine sediment – sand, silt, or mud. Fish eggs are held in openings between gravel and cobbles therefore good stream conditions support salmonid reds (nests) but when openings are filled with fines, eggs have no resting or breathing space and spawning is not supported.

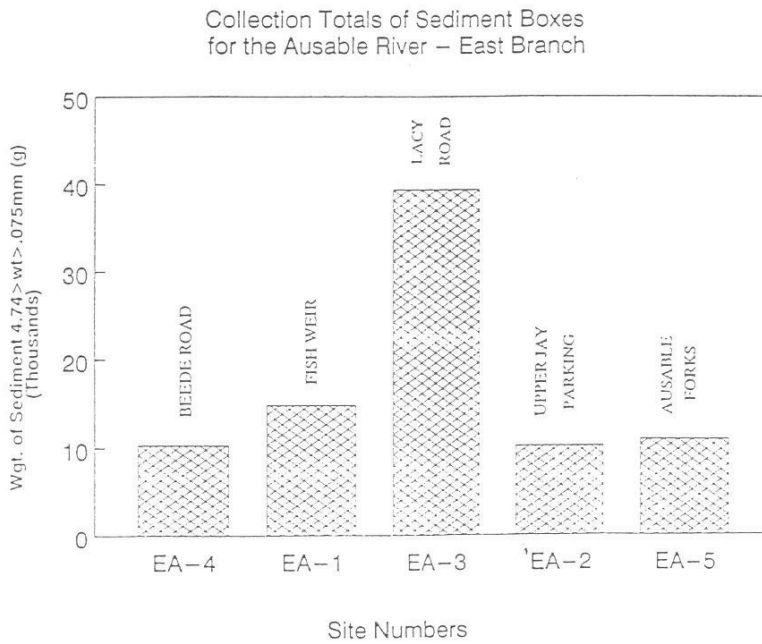
Figure B-3. Weight of sediment larger than silt smaller than coarse sand trapped in sediment traps on the bed of the Ausable River. Location correspond to embedness transects listed above.
