*Avoiding the impacts of river management through
river corridor and floodplain protection*

Mike Kline
Vermont ANR

Rivers
Program

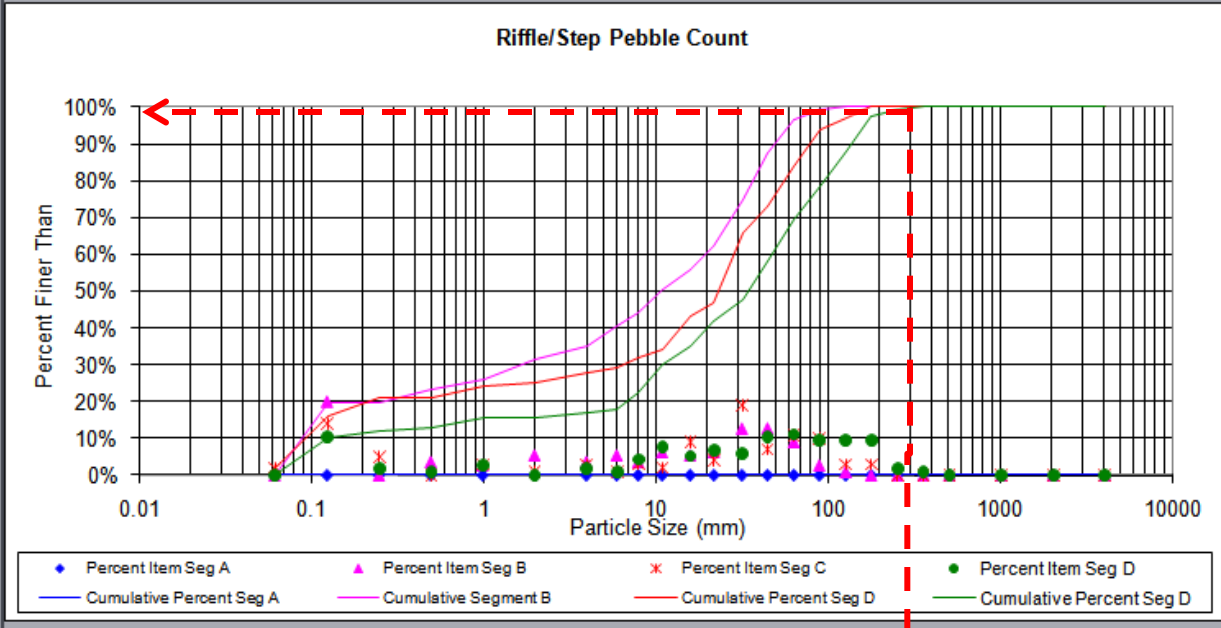
Stream Name: Lewis Creek Date: see notes
 Reach #: M22 Town: STARKSBORO

Size percent less than (mm)					Percent by substrate type					
	D16	D35	D50	D84	D95	silt/clay	sand	gravel	cobble	boulder	bedrock
Segment A											
Segment B	0.109	3.897	10.753	41.063	60.600	0%	32%	65%	4%	0%	0%
Segment C	0.125	11.468	23.341	64.000	101.212	2%	23%	59%	16%	0%	0%
Segment D	2.567	15.950	34.356	110.046	164.782	0%	15%	54%	30%	1%	0%

Reach Incision converts dominate process from depositional to sediment transport

Threshold Grain Size = 121mm (Phase 3 verification)

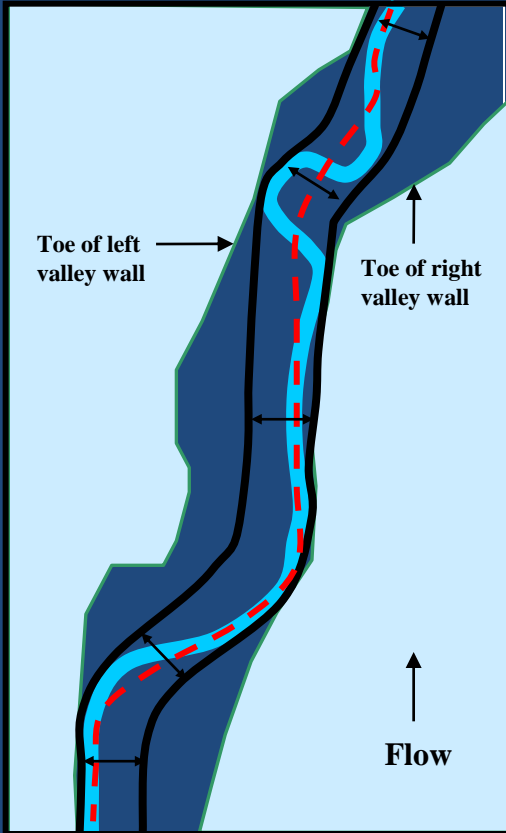
Belt Width

$$B = 3.7W^{1.12}$$

Using Williams Regression

Meander width ratio

$B/W = 5$ to 6 channel widths

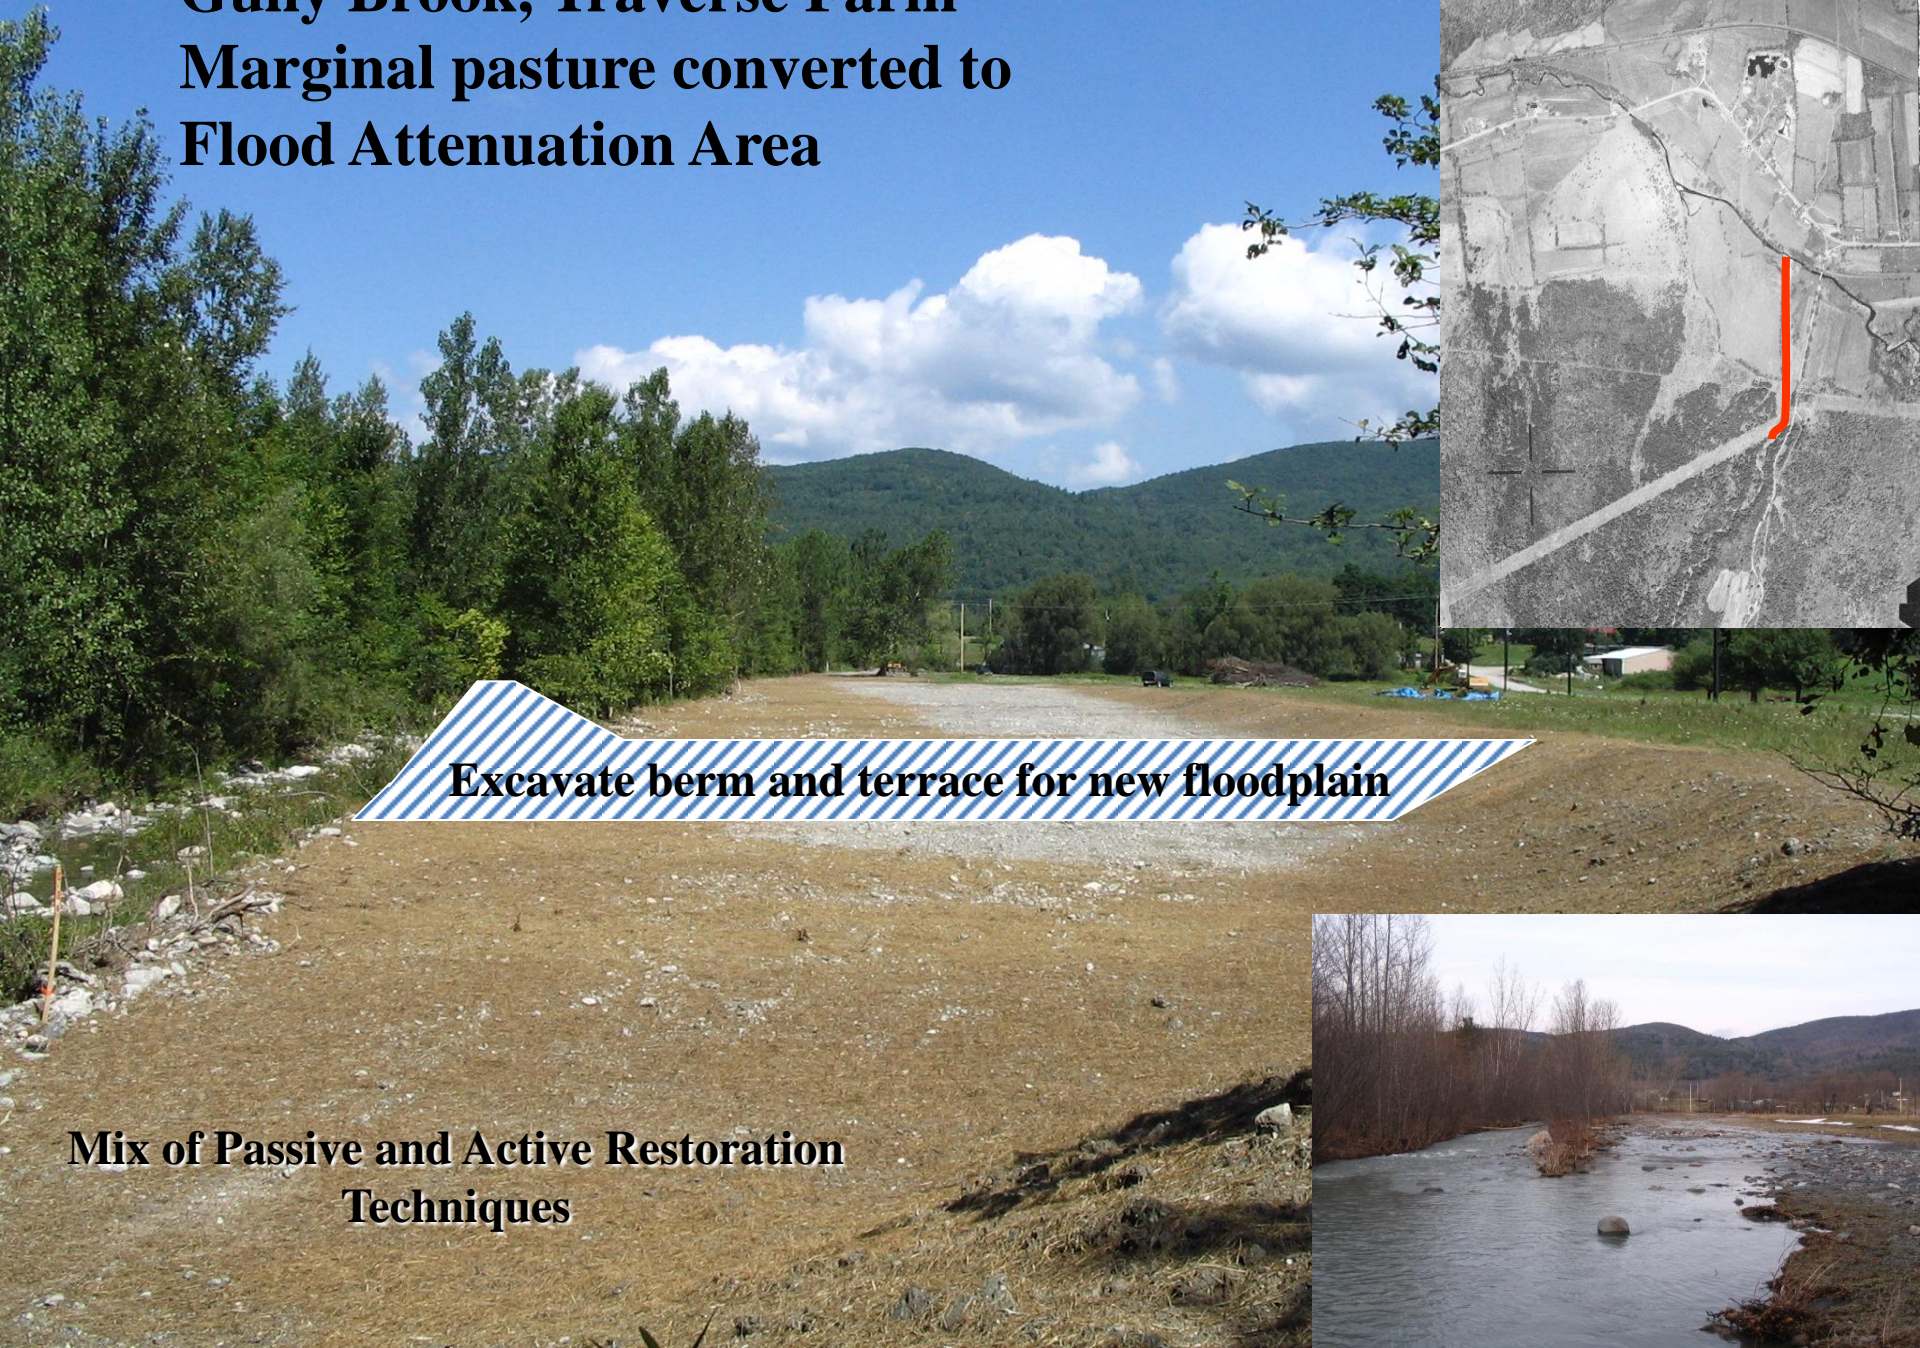
Gully Brook, Traverse Farm Marginal pasture converted to Flood Attenuation Area

Excavate berm and terrace for new floodplain

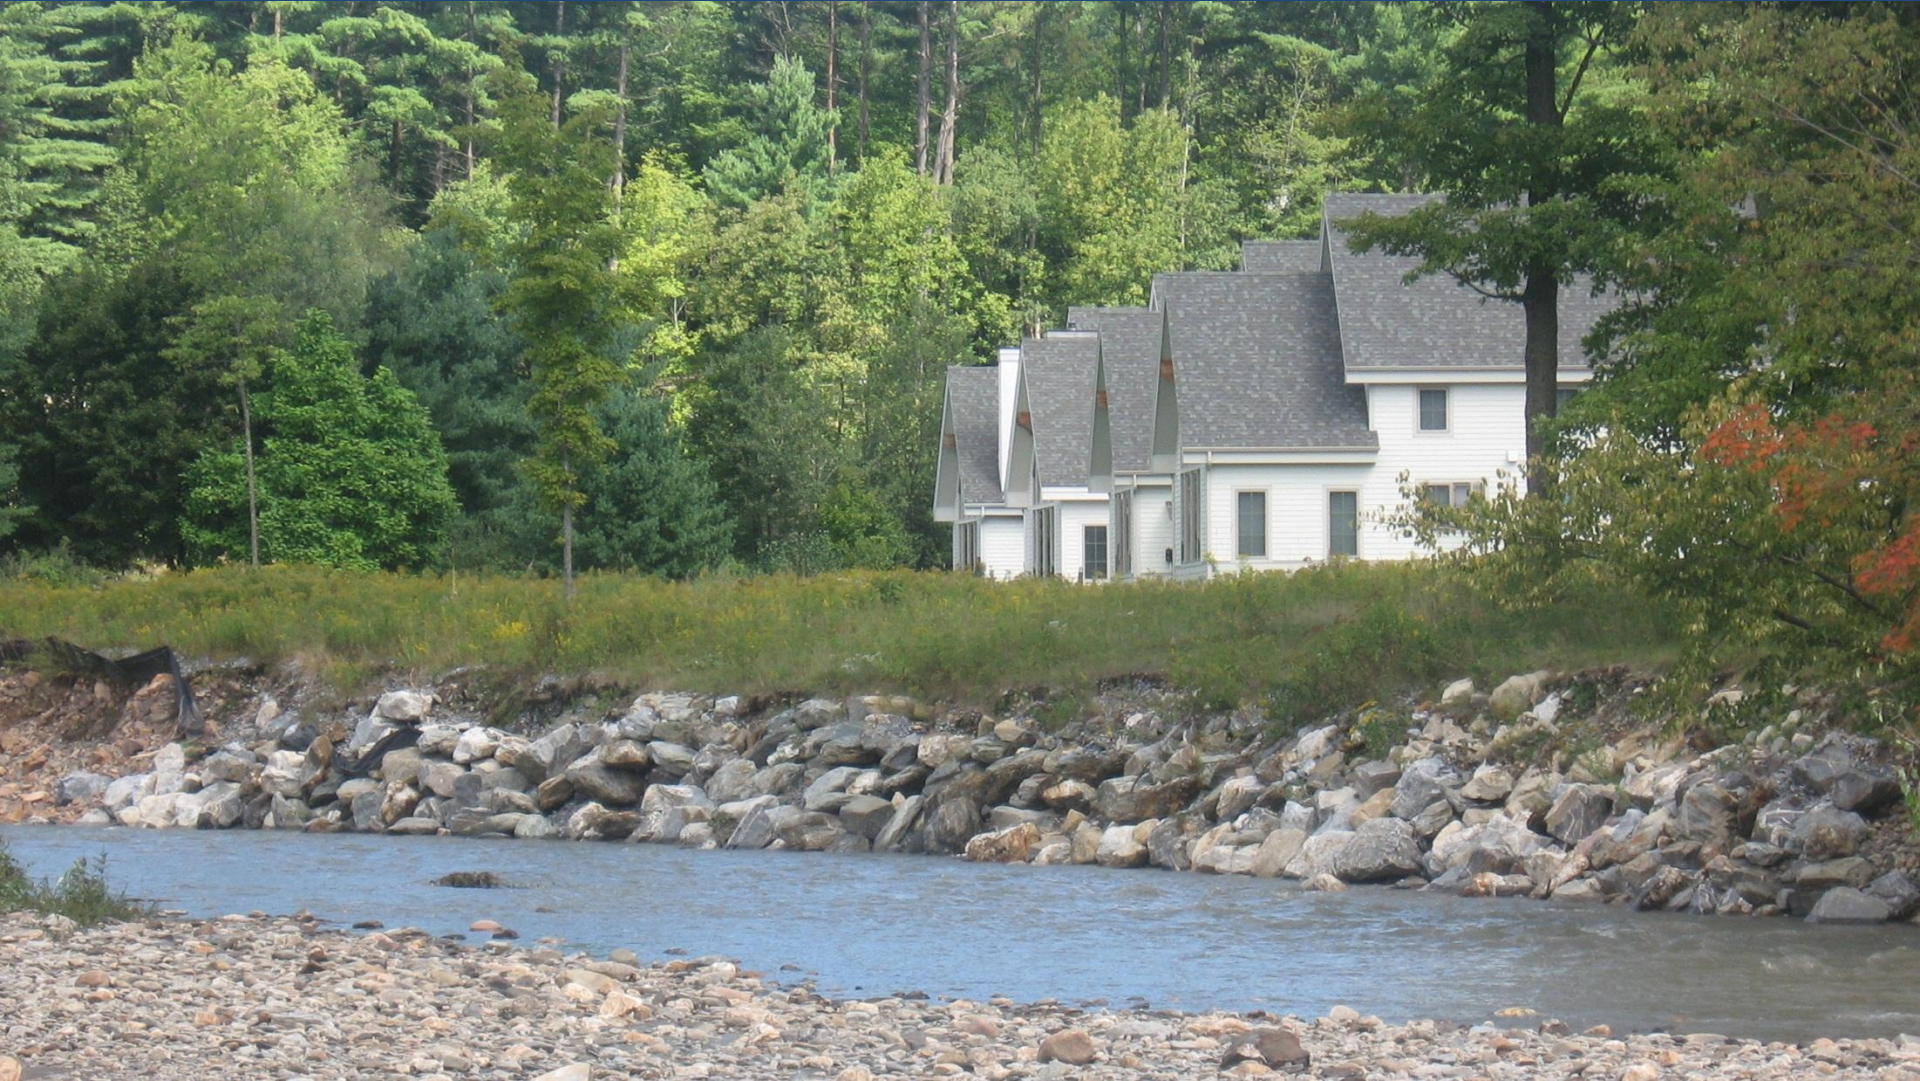
Rip-rap failing after seven years – ongoing maintenance costs
